# **EXHIBIT 21**

One  
SLA-1428  
D37362220-001-Ace Westchester  
MAX2XP0004029-Max Specialty  
Excess Property  
01/30/2009 TO 01/30/2010  
JY09J0336171  
Signal International, LLC  
P.O. Box 7007 Pascagoula, MS  
39568  
Port Arthur, TX  
08/20/2009  
Sunken dry dock, cause  
unknown

SLA-1428  
 September 2, 2009  
 Page 2 of 11

Resolve Marine Services, Inc. performed a dive survey of the sunken SITX Drydock from August 26 – 30, 2009. The purpose of the survey was to document conditions found on the drydock after the recent uncontrolled flooding and sinking event. This document represents a report of survey and conditions found.

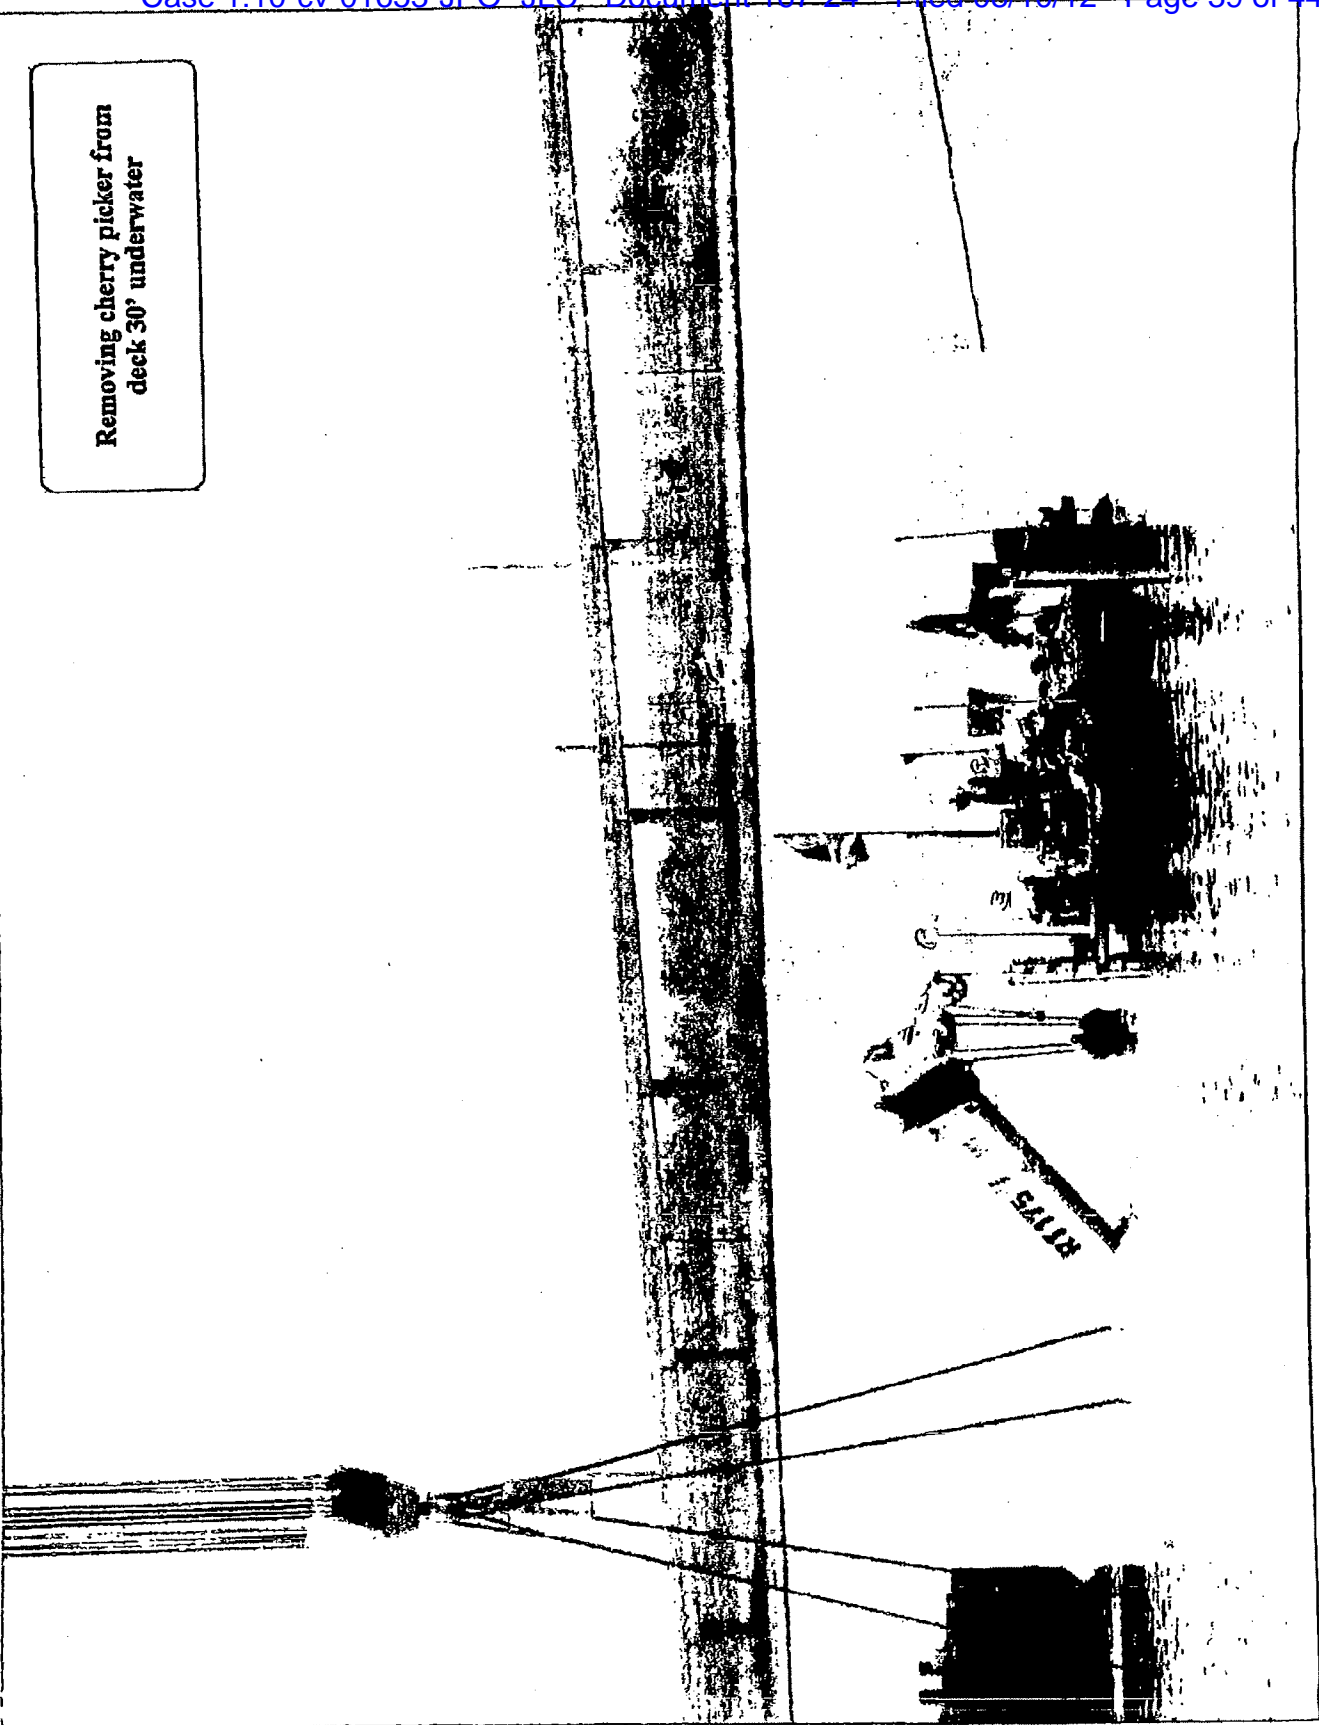
Removing cherry picker from  
deck 30' underwater
